## CTL Modular One Restoration Tasks

### 1. Modular One

# Redhawk Systems Limited

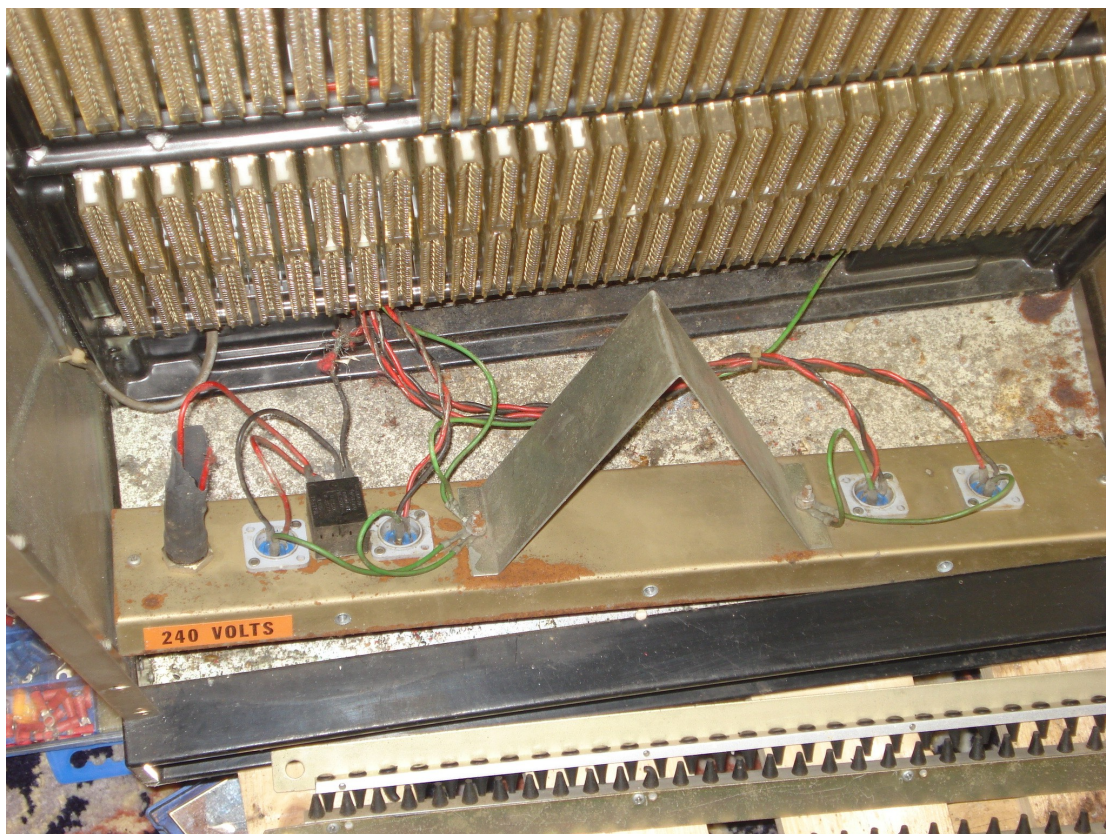
1. The mains power wiring in the base had been damaged by mice and would need replacing.
2. The main air filter had crumbled and fallen inside the machine.
3. The large Electrolytic capacitors in the power supply constituted a potential hazard as they had not been used for twenty years and could fail dramatically if they had deteriorated.

The lower power panel removed for rewiring.

Task	Status
Check the manuals for a wiring diagram of the power tray in the base of the computer that was damaged by the mice.	None found
Produce a Wiring diagram from the existing power tray.	Complete
Rewire the power wiring in the base of the computer that was damaged by the mice.	Complete

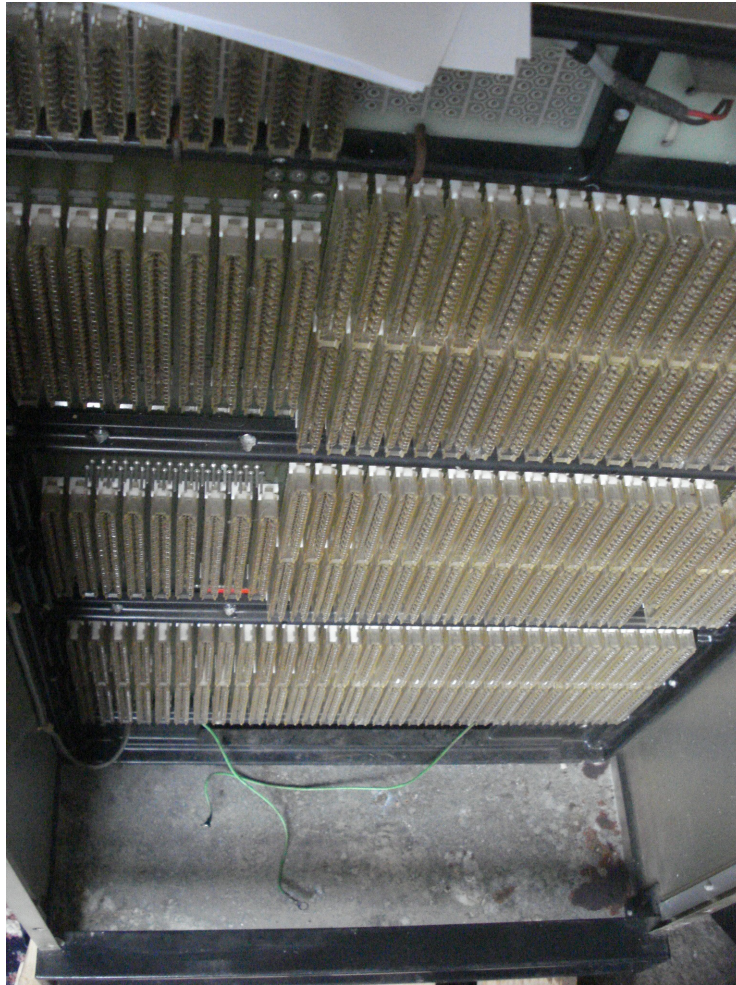
The full back plane with all the processor boards and power wiring removed.

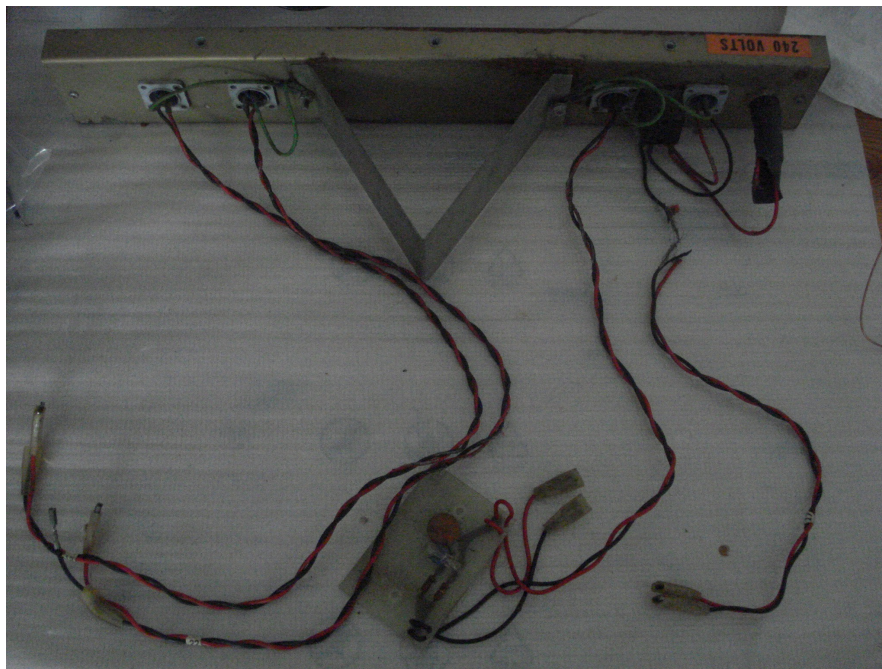
The power panel on the bench ready for re-wiring. The Modular one could be supplied with mains power locally through a mains cable or remotely via an auxiliary cable. The circuit board attached to the harness is fitted with a neon lamp which

indicates that the computer is being powered remotely, presumably to alert a Technician that is accessing the machine that the machine is live even though its mains cable may have been unplugged.

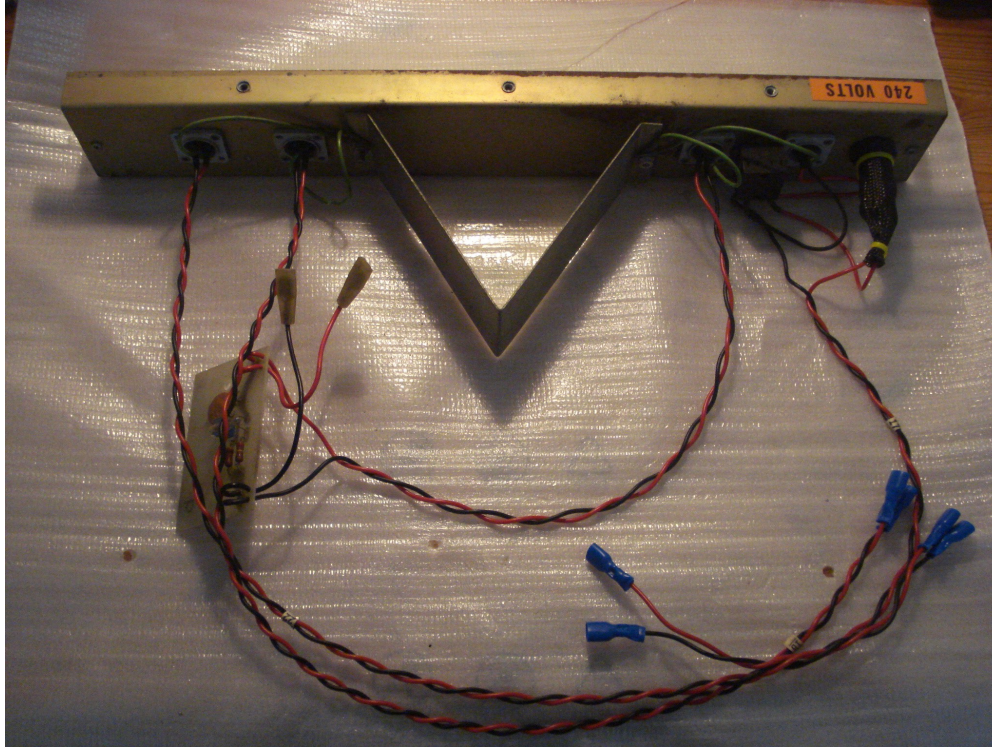
The rewired Power panel.

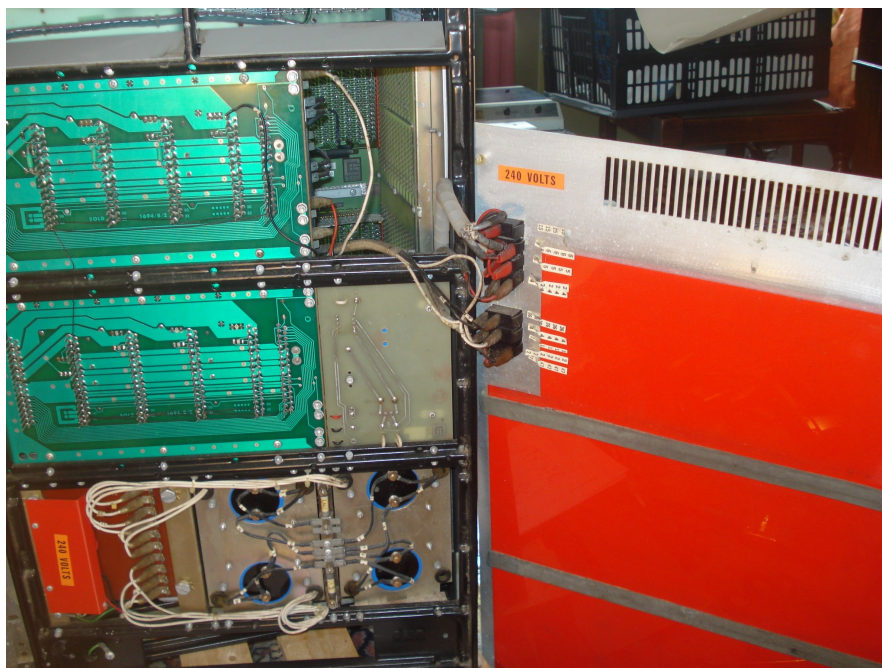
The power door with the cover removed.

Task	Status
Ascertain if the large capacitors in the power supply will still be viable.	Complete, obtained support from the manufacturer.
Remove and test the Electrolytic capacitors in the power supply	Complete. All OK after reforming

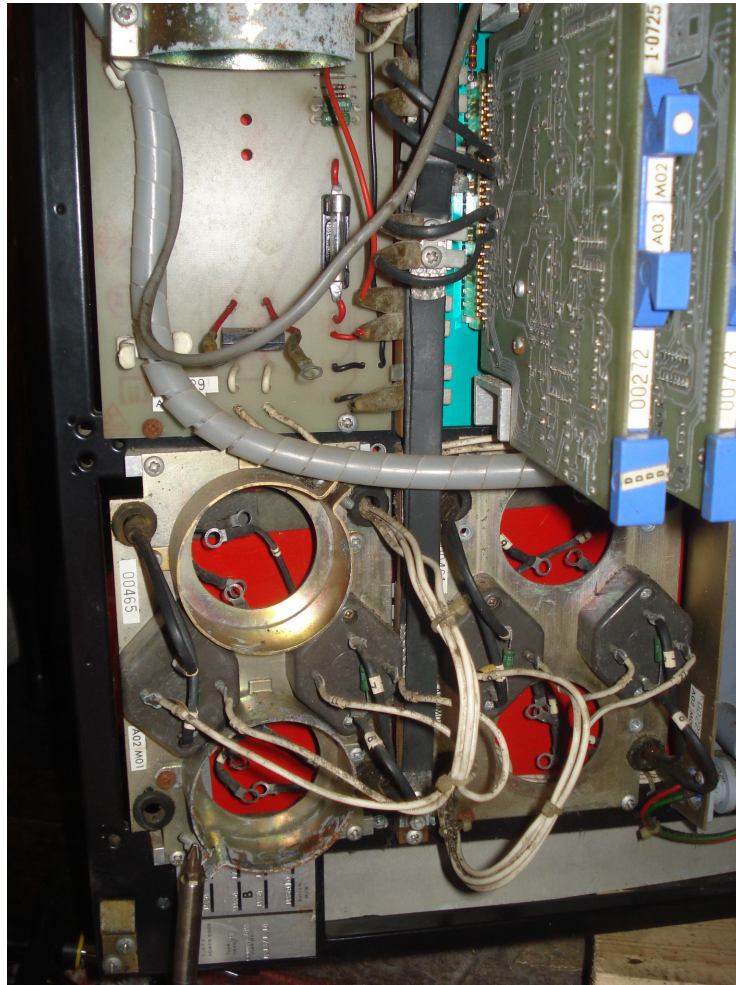
The Power door with the capacitors removed.

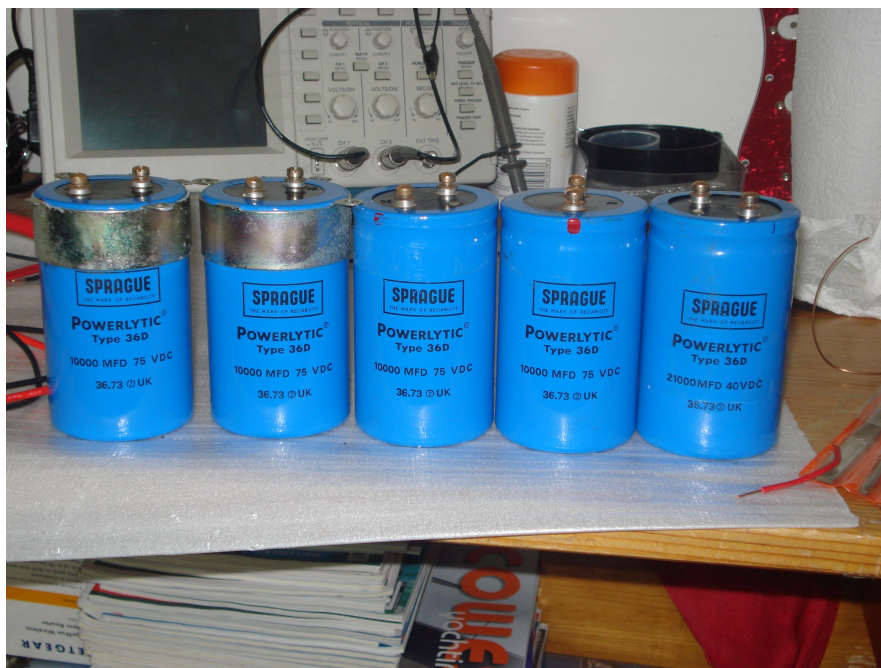
The capacitors on the bench for reforming.

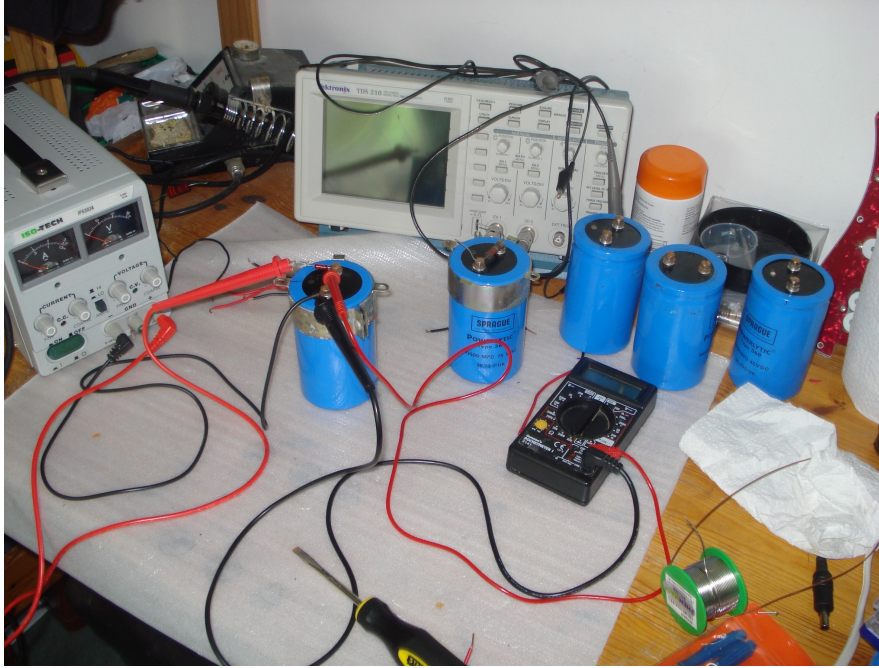
The 40 volt capacitor connected to the Bench power supply. An additional fixed power supply was added to raise the voltage to 70 volts for the 75 volt capacitors.

The initial leakage current was measured;

Capacitor	Initial Leakage current at 31.5 volts	
	Initial value	Falling to;
21000 $\mu$ F 40 Volts	0.3 mA	
10000 $\mu$ F 75 Volts #1	1.5 mA	
10000 $\mu$ F 75 Volts #2	5.0 mA	1.3 mA
10000 $\mu$ F 75 Volts #3	4.3 mA	1.0 mA
10000 $\mu$ F 75 Volts #4	100 mA

After soak testing the total leakage current for the four 10000  $\mu$ F caps wired in parallel fell to 0.21 mA

Capacitor	Measured Capacitance		% over tolerance
21000 $\mu$ F 40 Volts	25862.67606	$\mu$ F	23.15560027
10000 $\mu$ F 75 Volts #1	11393.30986	$\mu$ F	13.93309859
10000 $\mu$ F 75 Volts #2	11720.59859	$\mu$ F	17.20598592
10000 $\mu$ F 75 Volts #3	11606.16197	$\mu$ F	16.06161972
10000 $\mu$ F 75 Volts #4	12404.92958	$\mu$ F	24.04929577

The nominal tolerance is +/- 20% for these capacitors.

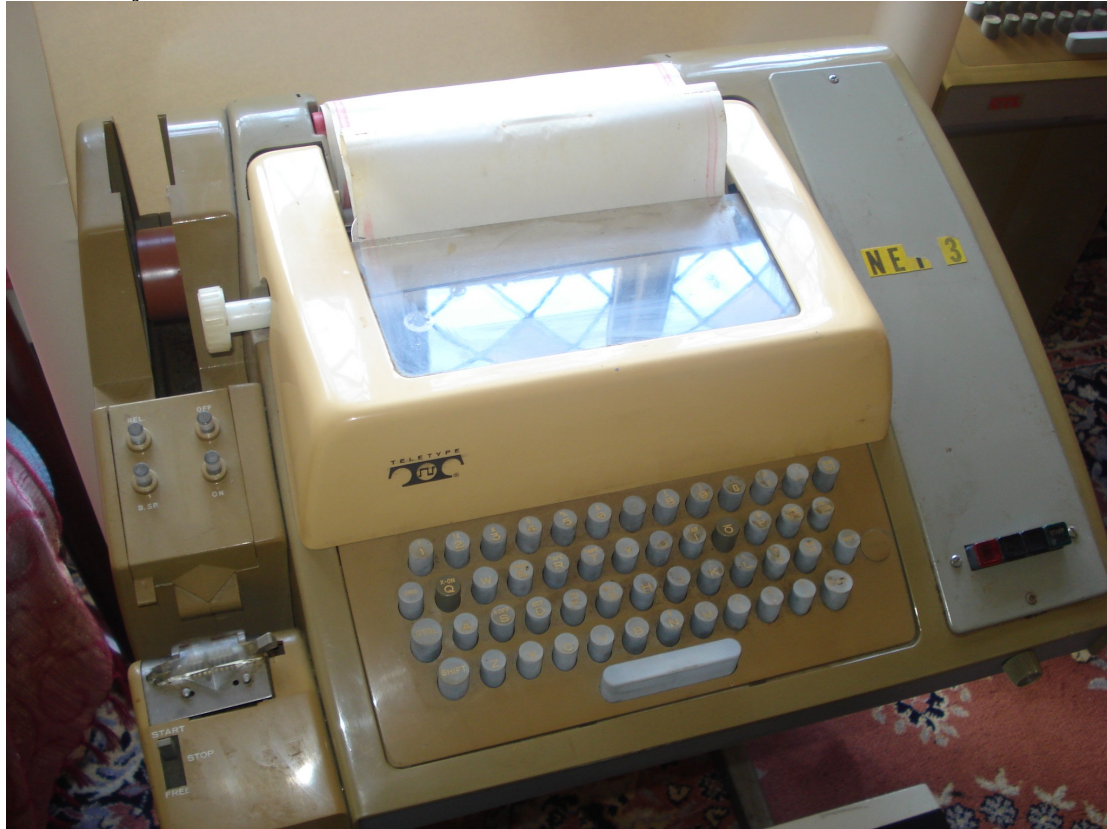
This Teletype was labelled “NET 3” when it was used at the National Physical Laboratory.

The Teletype was cleaned internally and the motor turned by hand to ensure that the major mechanisms were not stuck. The Teletype was powered up and run with the cover set alongside. When the Start button was pressed the drive motor ran, although at other times it stalled and had to be freed by hand.

Task	Status
Lubricate as per the TTY manual	Complete
Obtain a new paper roll and ribbon.	<i>Current items are just about serviceable for the time being</i>
Test TT keyboard off-line	Initially it failed, The Universal bar was stuck, now fixed.
Test Printer off-line	Initially failed see list of faults
Printer: The typing mechanism only prints the top line of characters on the Print wheel.	Fixed, two code bars (5&7) were not moving.
Printer: The Carriage return does not work.	Fixed, the function code bar was stuck.

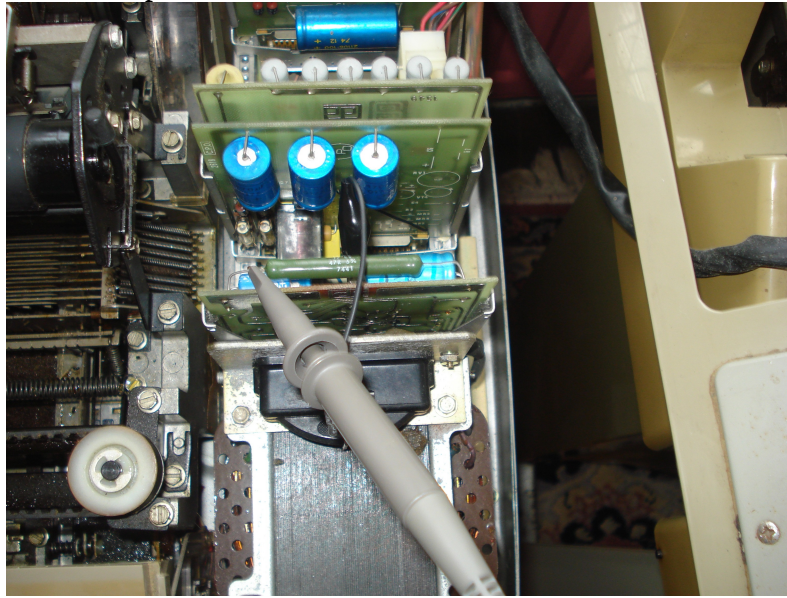
An Oscilloscope was used to determine if the cause of the missing bits was electrical or mechanical. The scope was connected to the Selector solenoid drive circuit.

Scope connected to the Selector drive circuit.

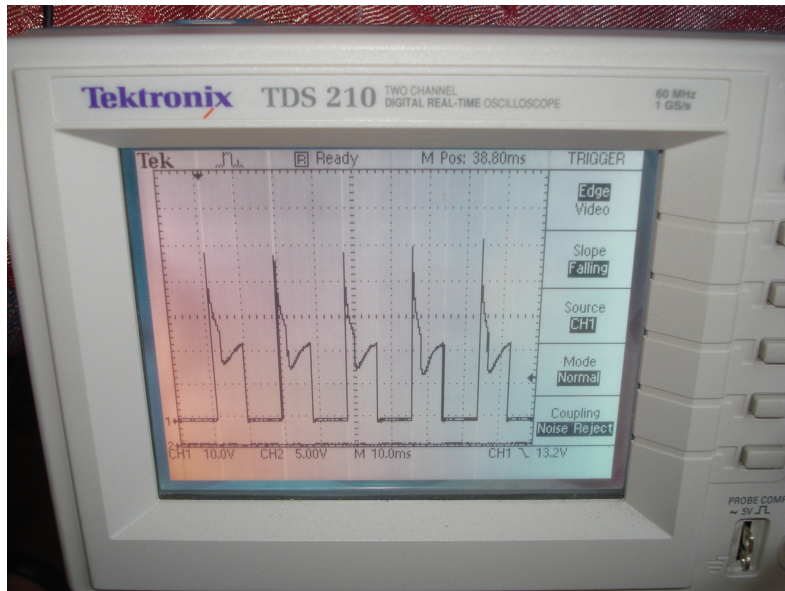
Character 'U' (0x55) displayed on the scope a positive voltage indicates that a bit is off. It could be seen by typing a range of characters that all the data bits were arriving at the solenoid. Therefore the problem must be mechanical and in the Typing mechanism.

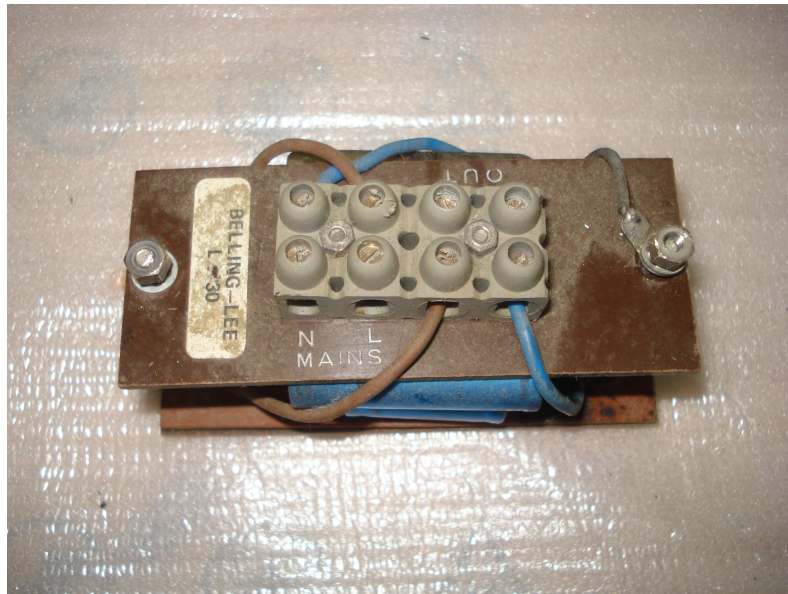
Task	Status
Test TT Tape reader off-line	Two bits missing due to the problem with the code bars (above) now fixed.
Test TT tape Punch off-line	Two bits missing due to the problem with the code bars (above) now fixed.
A capacitor in the Mains filter in the base of the Teletype stand failed. It had been working for a couple of weeks over many power cycles.	Replacement capacitors obtained and fitted. The Teletype is now fully working.

The Mains filter, probably added to the Teletype by CTL as it is not a Teletype standard part and is made by Belling-Lee a UK manufacturer.

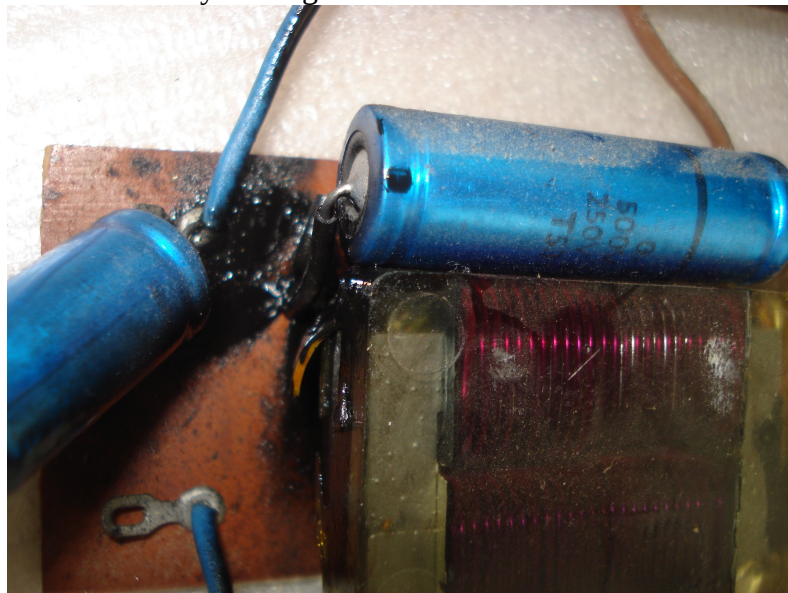
Black goo produced by the capacitor when it popped.

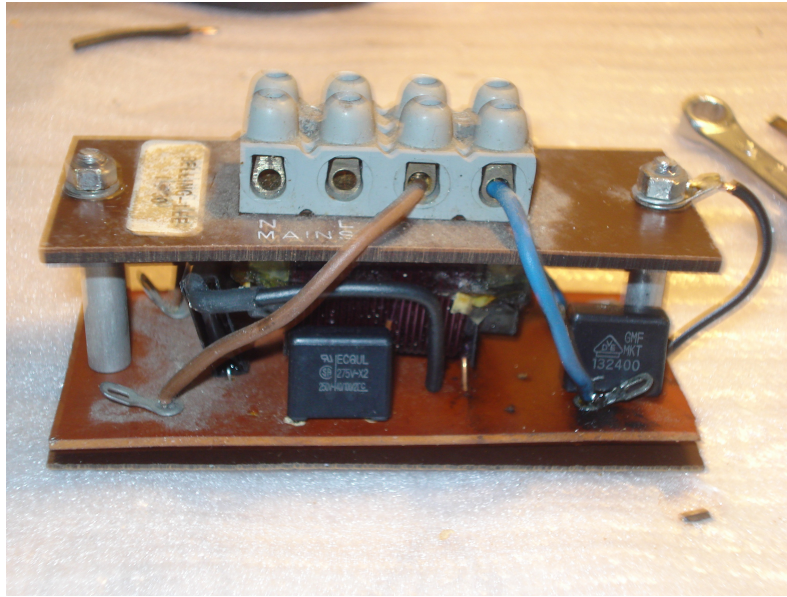
The repaired mains filter, all of the capacitors have been replaced with modern X2 rated capacitors used in RFI filters.

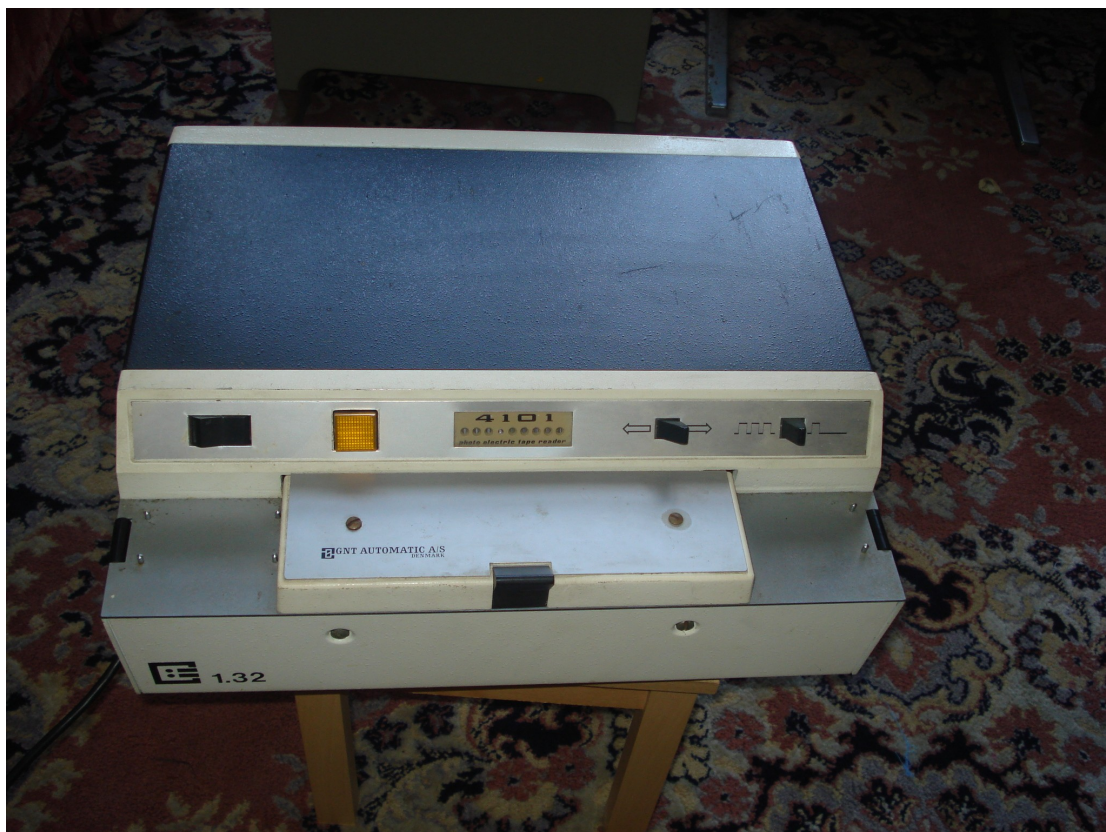
4101 Photoelectric paper tape reader. GNT Automatic A/S Denmark.

The Paper Tape Reader was powered up. The drive motor was running continuously (according to the circuit diagram in the manual this is normal). After a while smoke was emitted from the front left of the machine. On inspection this appeared to be

coming from the suppressor fitted to the mains switch. A capacitor on the power card was leaking an oily substance. The power card was removed and cleaned.

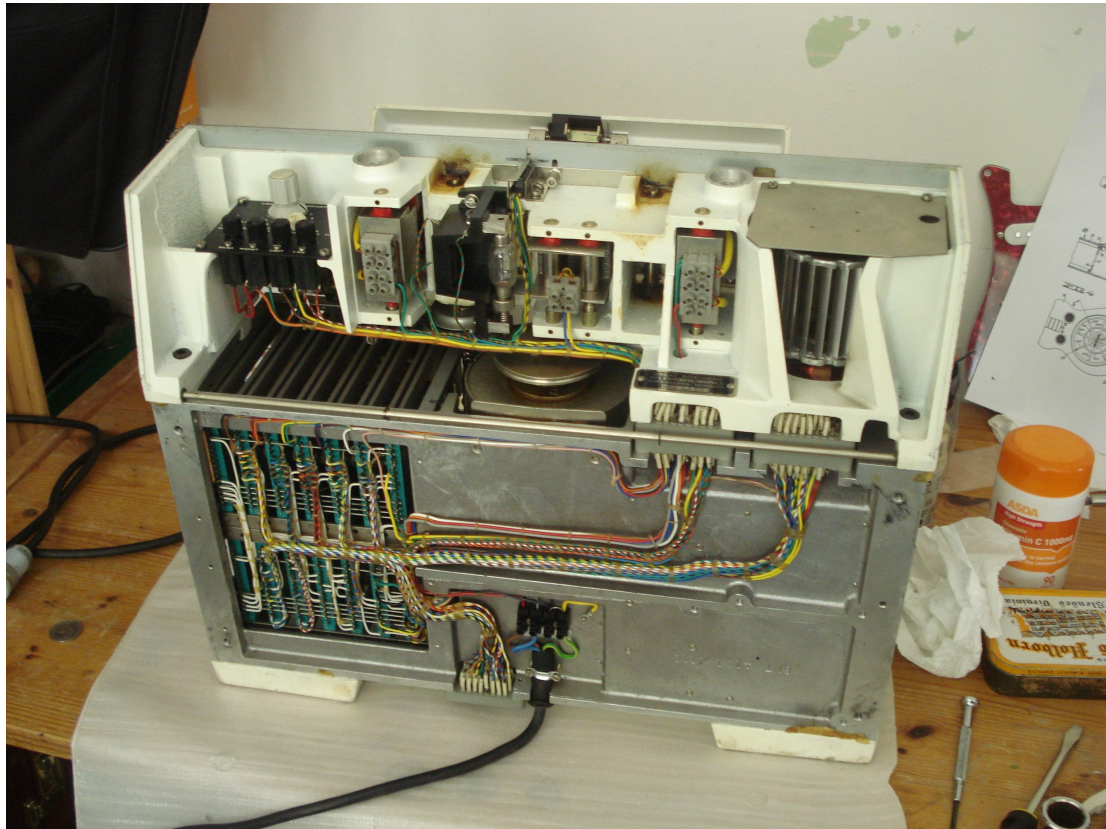
The PTR with the front cover and bottom cover removed. The Electrical connectors between the front and the main sections are on the right below the fan.

Initially it appeared that replacing the suppressor would be difficult because of access to the front panel. However, the machine is designed so that the front unbolts and unplugs from the main chassis. In addition it is necessary only to remove the drive belt to separate the two parts.

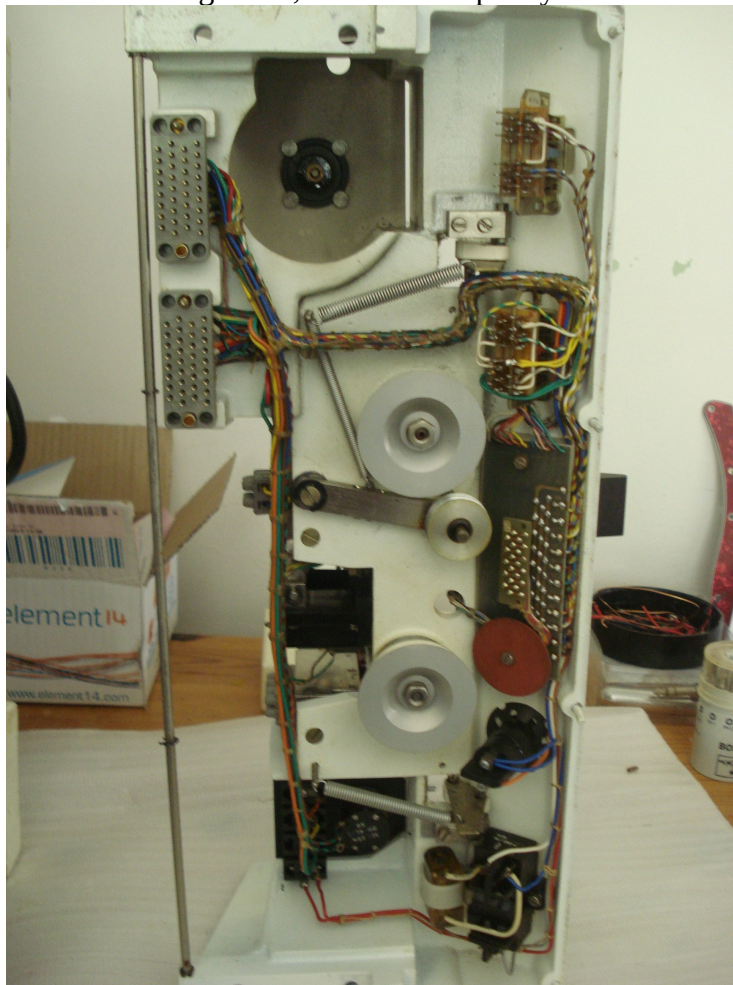
The front section separated from the main chassis. The faulty suppressor is clipped next to the power switch (bottom right).

Task	Status
Obtain and fit a replacement Suppressor	Complete

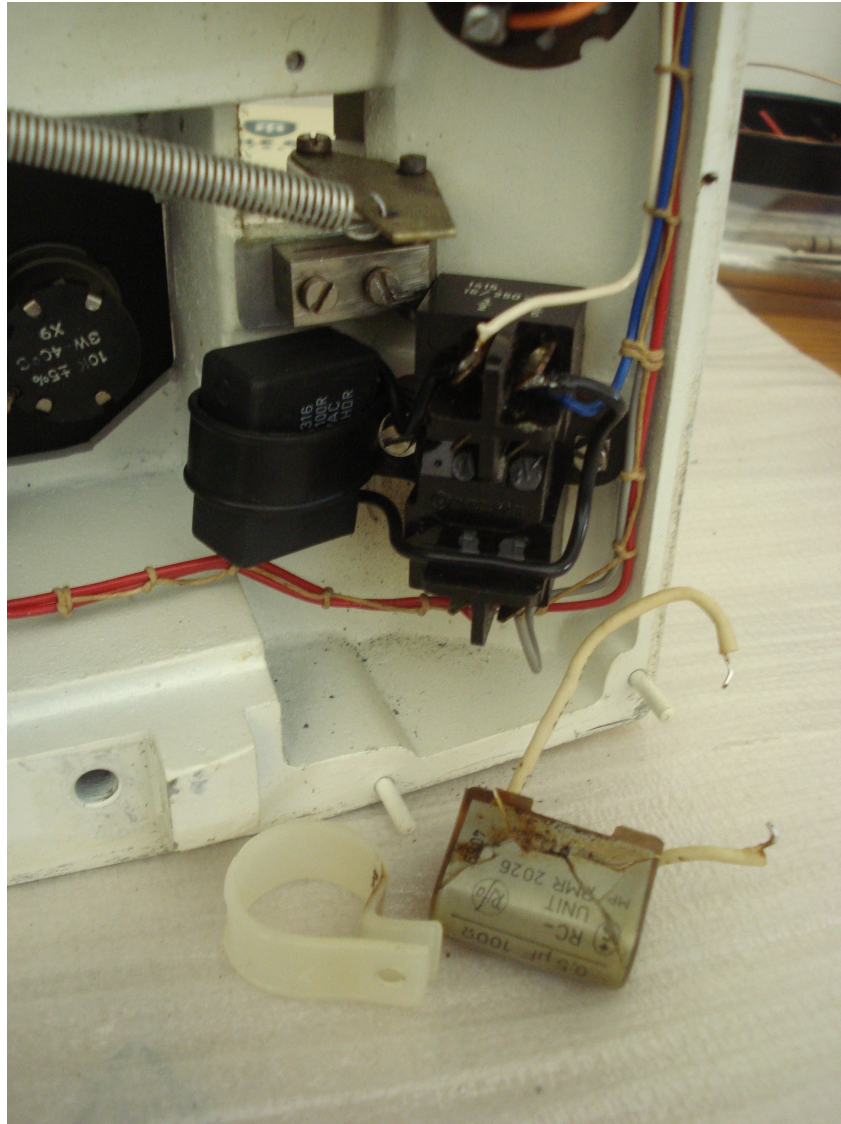
The old cracked suppressor and clip have been removed and the new suppressor and clip are fitted to the switch.

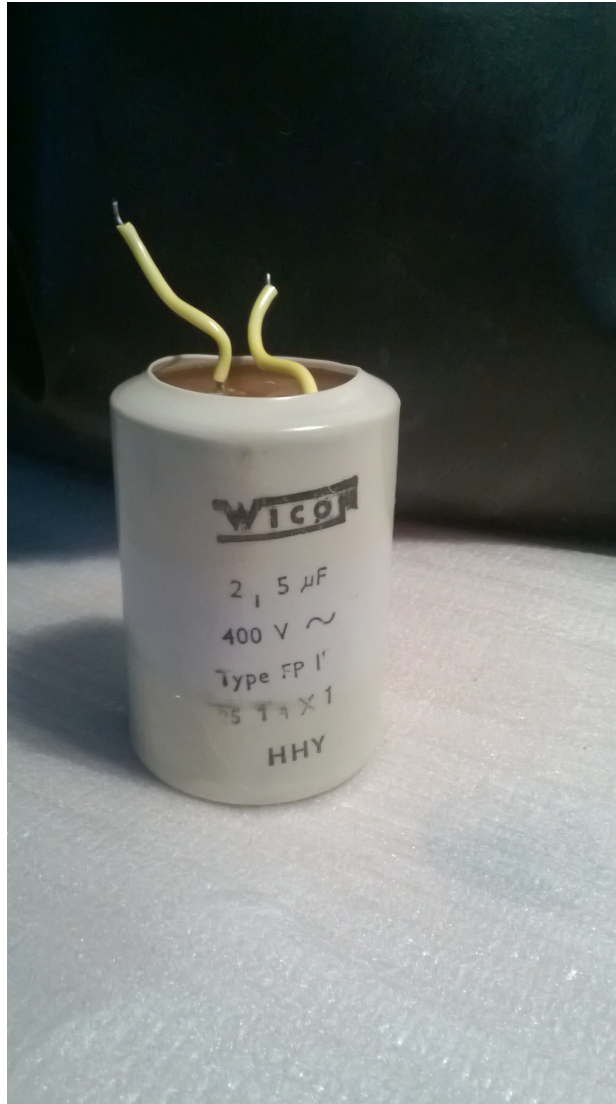
The old leaky capacitor removed.

Task	Status
Obtain and fit a replacement Motor Run Capacitor	The replacement capacitor has been fitted and the motor runs.

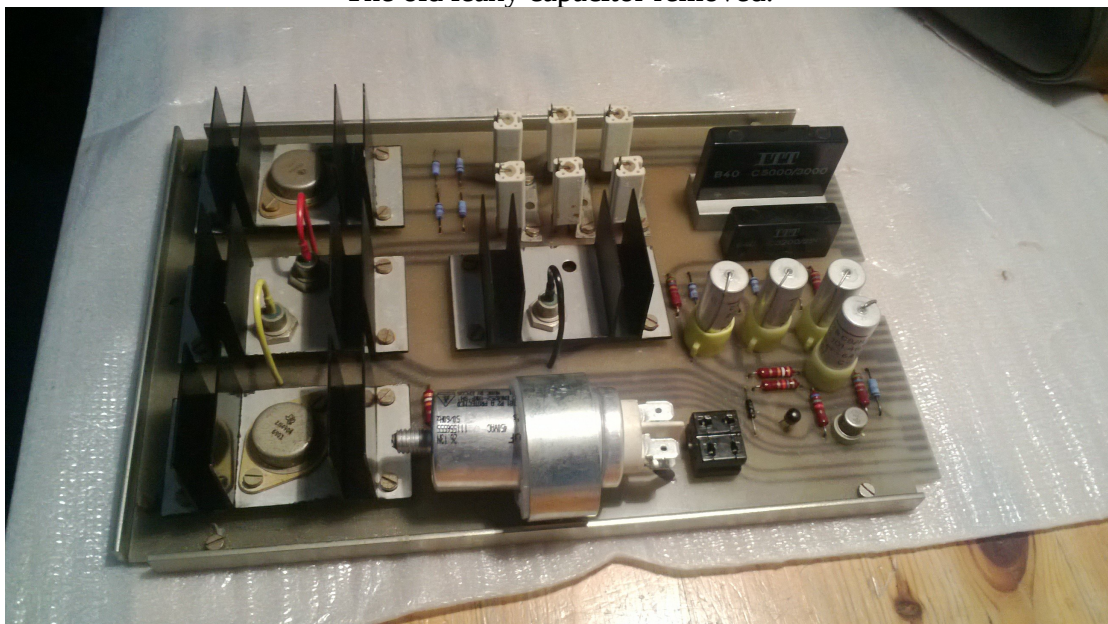
The new capacitor fitted.

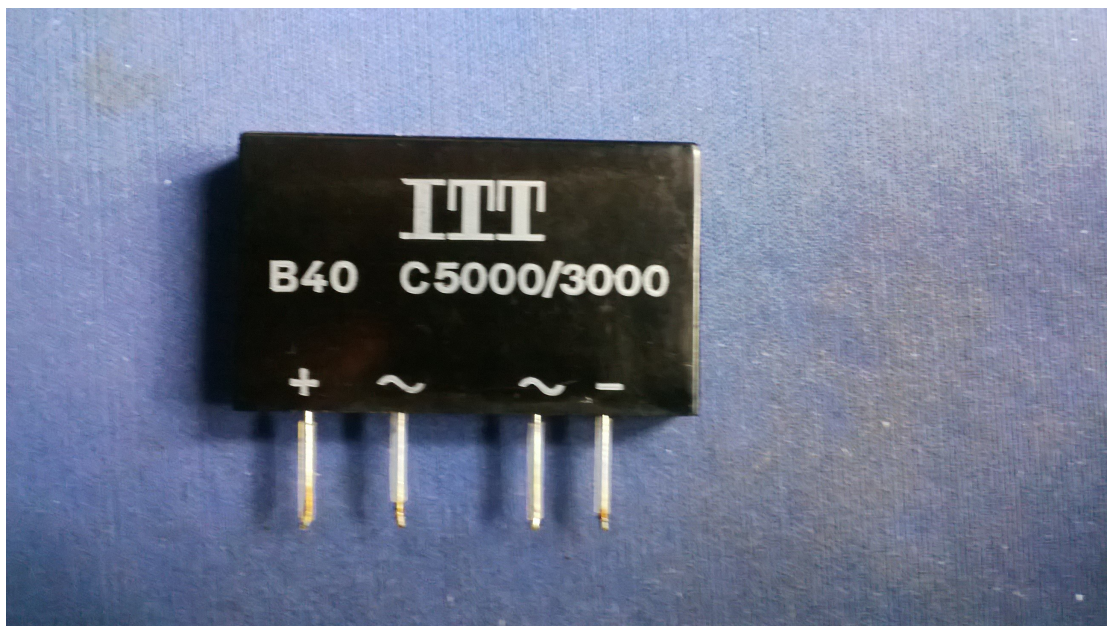
Task	Status
Power up and Test	Failed: The tape feed was not working. The electromagnets that engage the pinch rollers onto the paper tape were not being energised. On investigation the rectifier in the power supply was only delivering 0.5 volts.
Obtain a replacement Bridge rectifier D1. Type: ITT B40 C5000/3000 part number: 4101/211-41	This part is obsolete, but I have found one in France. Awaiting delivery by 28-09-2013.
Run a test tape through and monitor the output signals.	A test tape was pulled through by hand and the sensor head appears to be working as the indicator lights are operating for every data bit.

The faulty rectifier.

Task	Status
Replace the Bridge rectifier. D1	
Power up and Test	
Run a test tape through and monitor the output signals.
